Access Study to all Pertinent Parts of  
Dam Projects During High Reservoir  
Conditions

# Upper Connecticut Basin New Hampshire and Vermont

JULY 1992

US Army Corps  
of Engineers  
New England Division

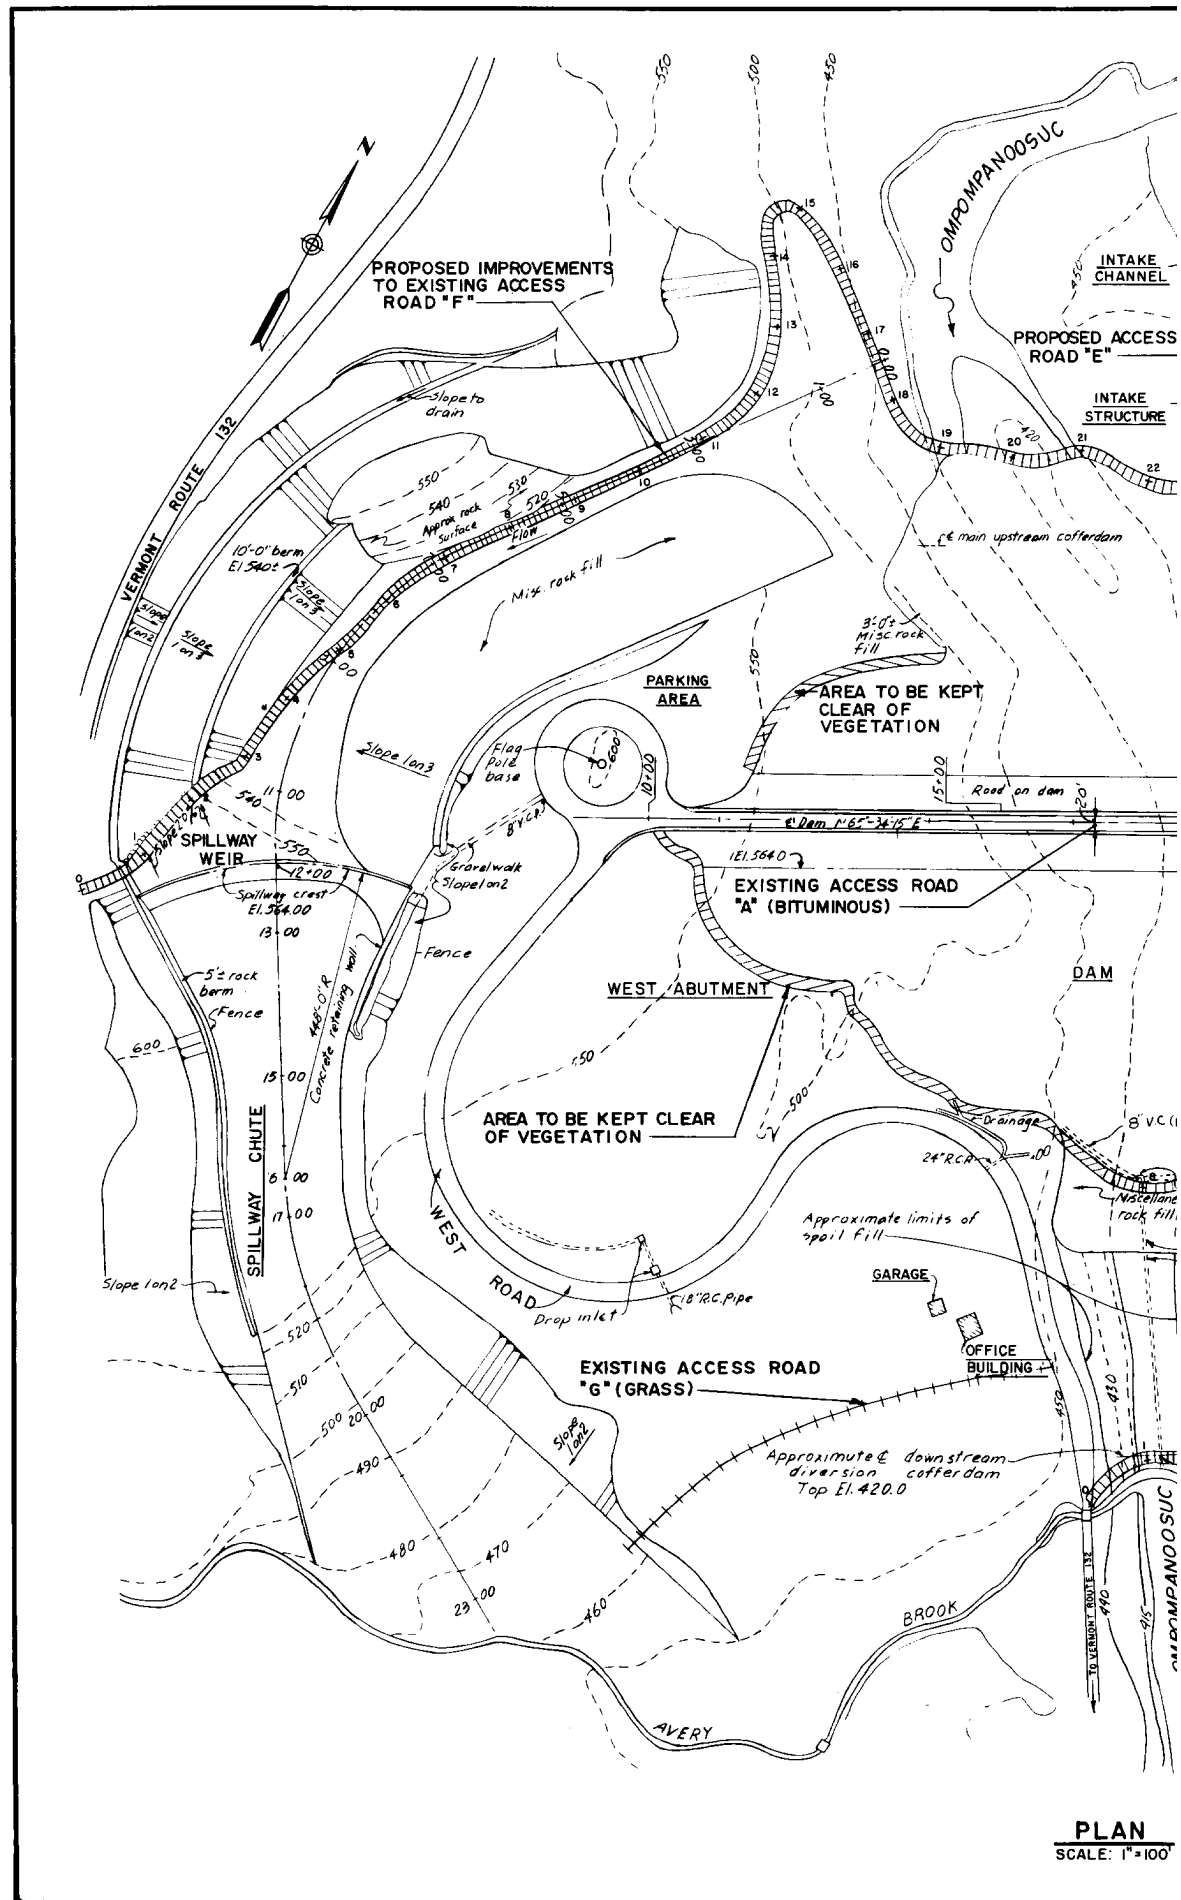
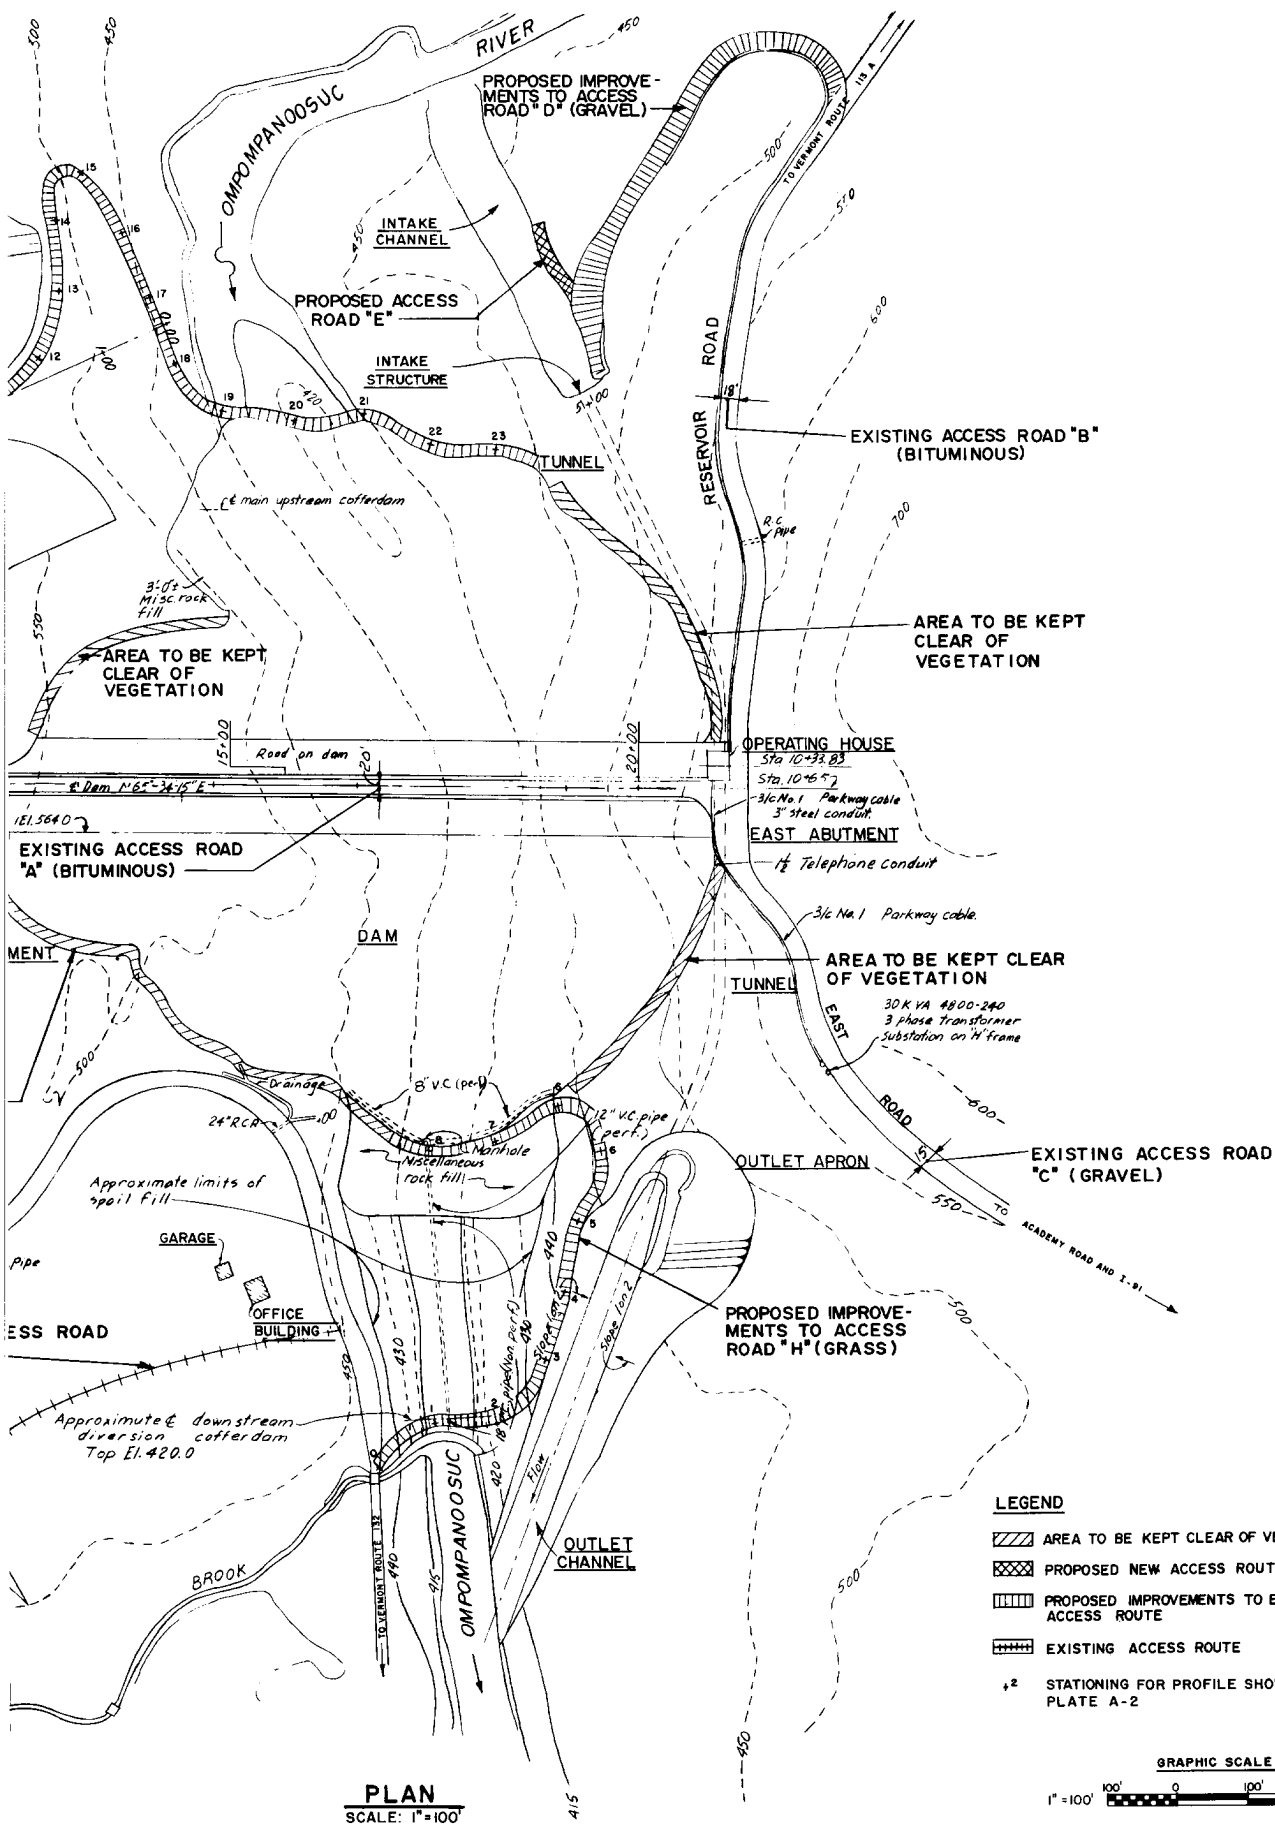
DES. BY.		EM UPPE
DR. BY.		
CK. BY.		
GEOTECH. ENG. DIV.		
PLATE A-1

3. Adequacy of Access. The grassy area in the immediate vicinity of the downstream toe does not meet design criteria. Heavy equipment would probably have difficulty operating in the downstream toe area during spillway discharge. Only equipment under eight tons in weight could reach the toe area once spillway discharge conditions occurred because of the load limitations on the Academy Road covered bridge.

6. Adequacy of Access. Access to the crest of Union Village Dam is adequate. Presently, access to the lower portion of the upstream toe of the dam is inadequate during normal pool conditions.

4. Recommended Improvements. Access Road "H" as shown on Plates A-1 and A-2 should be improved in the downstream toe area. Flattening of the gravel ramp at West Road and a steep slope on the east side of the old Ompompanoosuc River channel would be required to improve Access Road "H". The improvement would also provide better access to the outlet channel and structure. Upgrading the covered bridge on Academy Road to allow a higher load limit is beyond the scope of this study.

7. Recommended Improvements. Access Road "F" should be improved, as shown in Plates A-1 and A-2, so that the upstream toe and slope of Union Village Dam can be reached during normal pool conditions. Flattening two steep slopes and placement of a significant amount of rock fill will be required to improve Access Road "F".

10. Recommended Improvements. Access Road "D" should be cleared, grubbed, widened and surfaced with six additional inches of gravel to make it easier to use the road. Access "E" should be constructed as shown in Plates A-1 and A-2 to provide access to the north 100 feet of the inlet channel. Access Road "H" should be improved as discussed in paragraph 4 to provide better access to the outlet channel and structure.

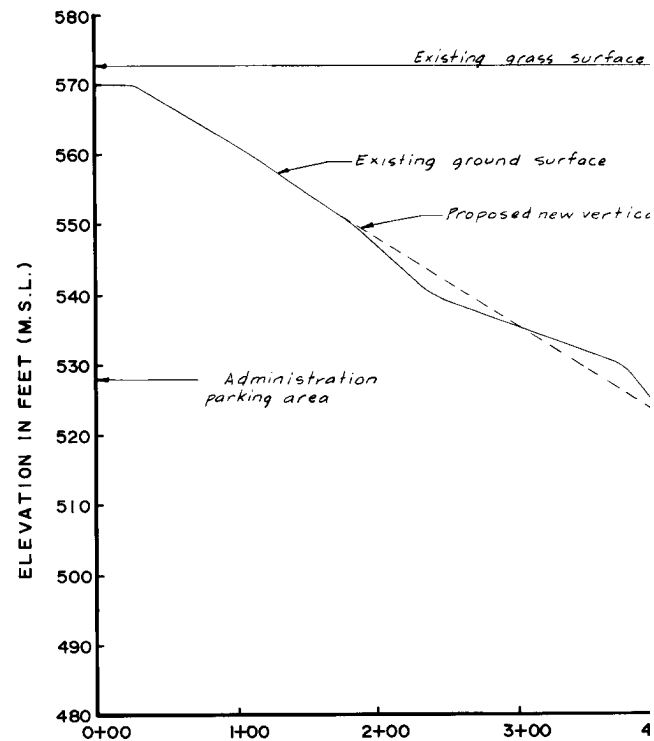
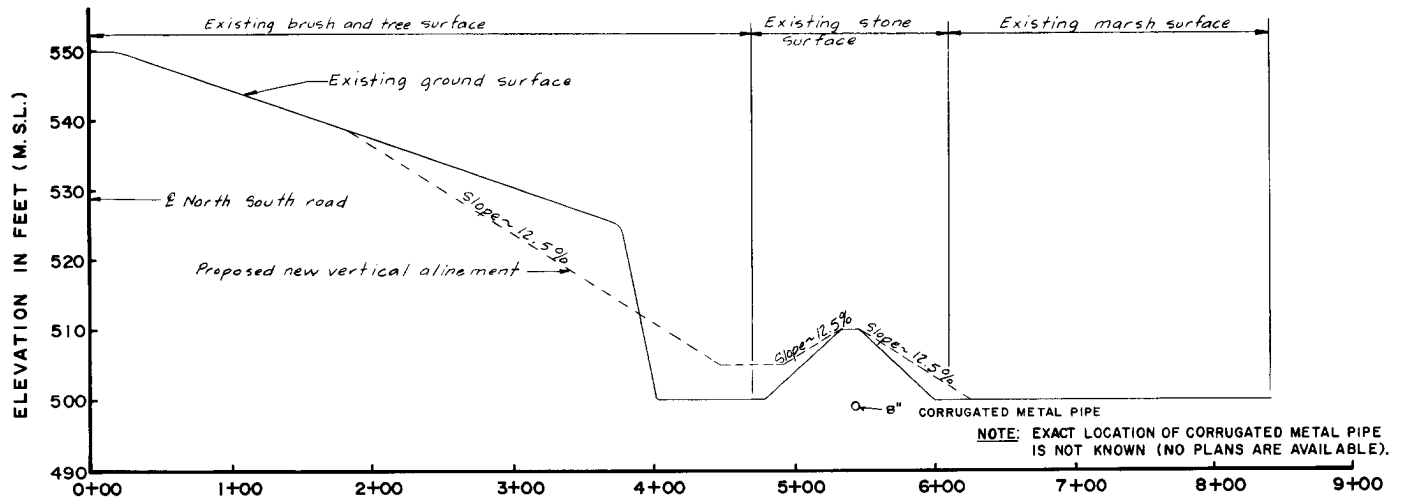
**PROPOSED ACCESS ROAD "N" PROFILE**

15. Adequacy of Access. Access to the crest of the North Branch Dam is adequate. Access to the toes of the dam is inadequate.

16. Recommended Improvements. Access Road "N" should be constructed as shown on Plates C-1 and C-2 to improve access to the downstream toe of the North Branch Dam. Access Road "O" should be constructed to improve access to the upstream toe of the dam. It would be a 12-inch gravel road at existing grade. Clearing, grubbing and stripping would be required before placement and compaction would be performed. The east abutment should be kept clear of vegetation to allow light weight vehicle and inspection along the abutment and North Branch interface.
